# 4-Point Inspection Form

Veritas Home Inspections  
Franz Chamorro  
(941) 416-6843  
franz@vhomeinspection.com

Insured/Applicant Name: \_\_\_\_\_ Application / Policy #: \_\_\_\_\_  
Address Inspected: 2800 Poplar St., Sarasota, FL 34237  
Phone: \_\_\_\_\_ Email: \_\_\_\_\_  
Actual Year Built: 1953 Date Inspected: 12/21/2024

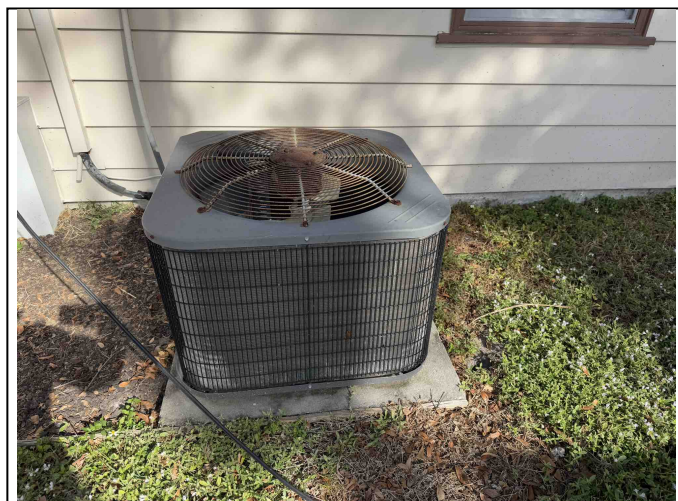
ICP Condenser Unit

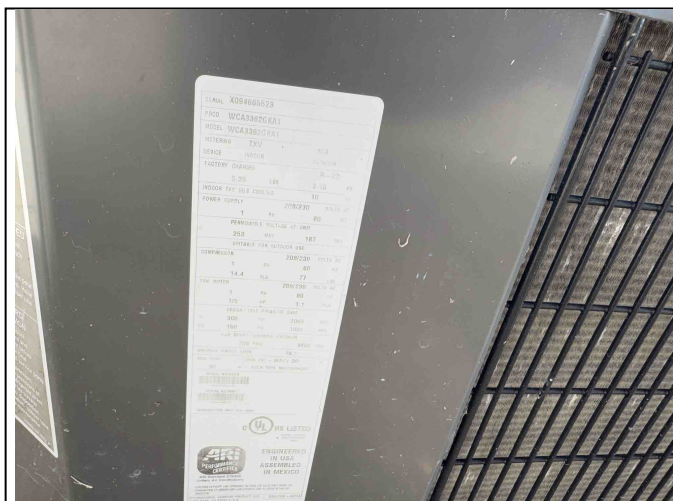
Mfgt.date:2009

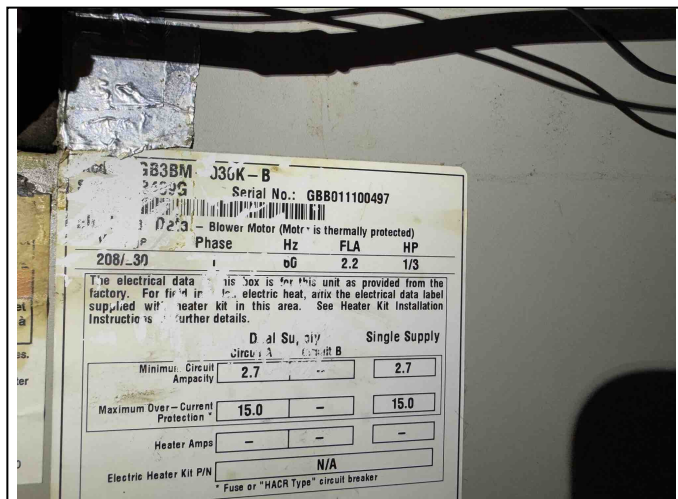
Mfgt.date:2001

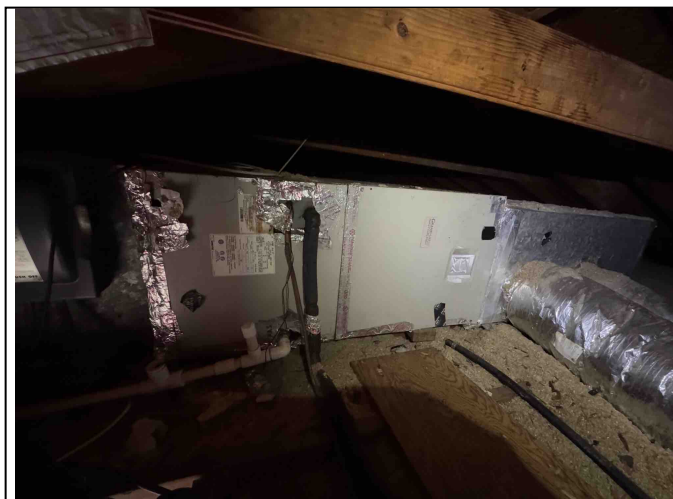
Nordyne Ar handler

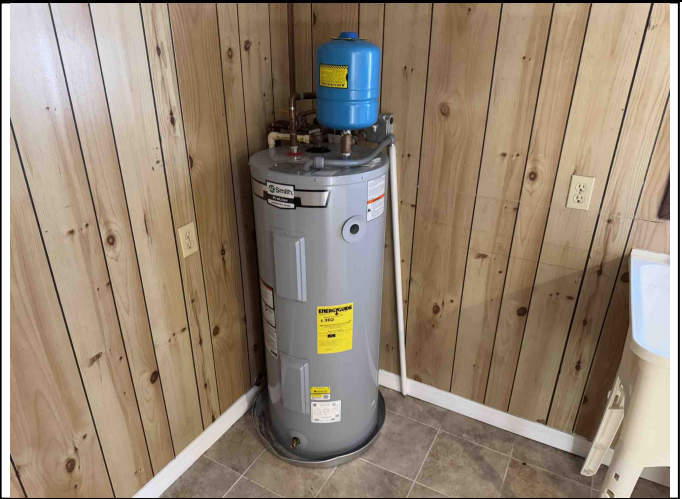
AO Smith Water Heater

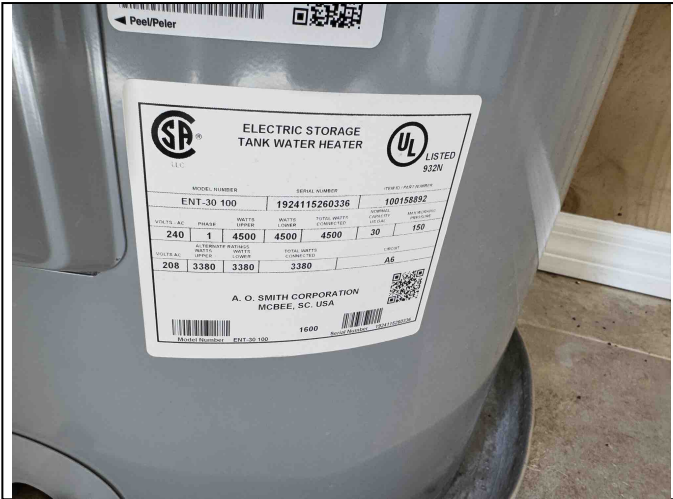
Mfgt.date:2019
